Li, Z and Haigh, A and Soutis, C and Gibson, A and Sloan, R and Karimian, N (2016) Delamination detection in composite T-joints of wind turbine blades using microwaves. *Advanced Composites Letters*, 25 (4). pp. 83-86.

DELAMINATION DETECTION IN COMPOSITE T-JOINTS OF WIND TURBINE BLADES USING MICROWAVES

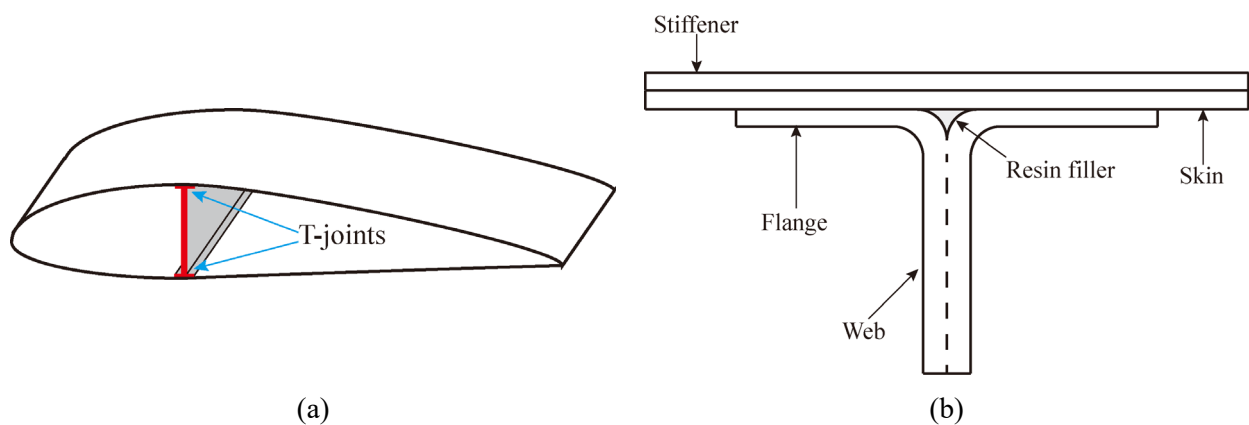
As illustrated in Fig. 1 (a), the T-joint in the wind turbine blade is a vital component, which provides the connection between the web and the skin. Specifically, as presented in Fig. 1 (b), the T-joint under test is made up of the web, flange, skin and stiffener [9]. The delamination between the flange and the skin is the common damage type in the field due to the relatively low interlaminar strength. It is important to introduce a NDT technique for detection and evaluation of the delamination, since it is difficult to see the damage from the outside by naked eyes.

Fig.1: Schematic diagram of the GFRP composite T-joint:

(a) Cross-section of the wind turbine blade, (b) Structure of the T-joint under test

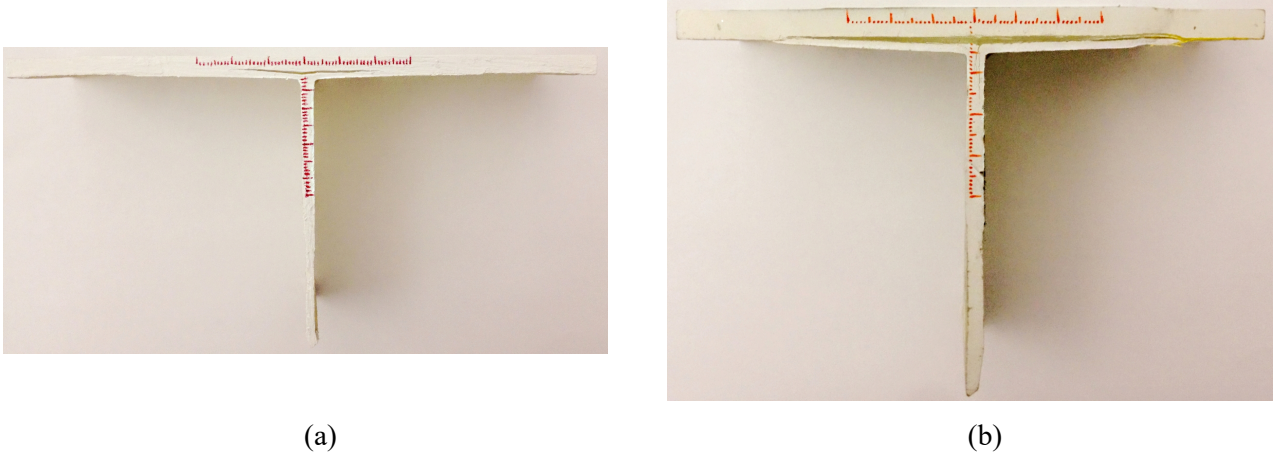
Two T-joint samples under test denoted by T-joint I and II are shown in Fig. 2. The stacking sequence of the flange and skin is $[45^\circ/-45^\circ]_5$, and the web is a $[45^\circ/-45^\circ]_{10}$ plate. The stiffener

consists of five-layer unidirectional $[0^\circ]_5$ to prevent large deflections. The delamination in each sample was induced by the pull-out test. Total thicknesses of the cured base (flange, skin and stiffener) of T-joint I and II are 7.66 mm and 8.66 mm, respectively.

Fig.2: Photographs of two GFRP T-joint samples: (a) T-joint I, (b) T-joint II

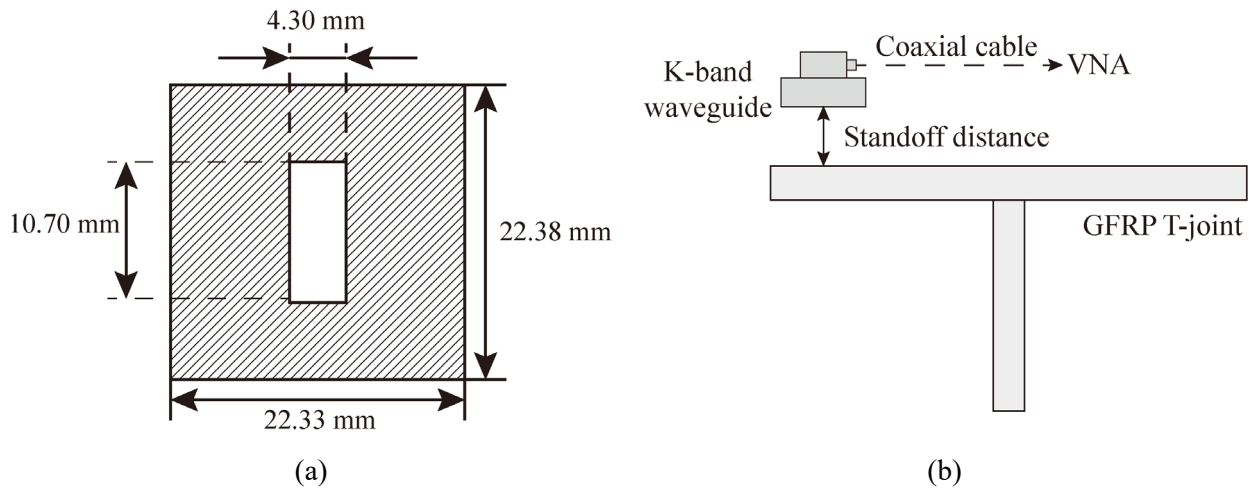
The microwave imaging with an open-ended waveguide is employed because of its easy setup, capability of non-contact inspection and no need for signal processing or significant operator expertise [10]. In the test, a K band (18.0-26.5 GHz) rectangular waveguide adapter is used. The dimensions of the waveguide are presented in Fig. 3 (a). The waveguide assembly is mounted on an XYZ scanning stage and connected to an HP8720D vector network analyser (VNA) (50 MHz-20 GHz) by a semi-rigid coaxial cable. A personal computer (PC) is connected to the PIC18C452 Microchip® microcontroller for the logic control of the stepper motors. VEE software® is employed for precise and reproducible movements of the sensor. In addition, the analyser is connected to the PC by the IEEE-488 cable for data acquisition. The frequency range employed is 18-20 GHz.

Fig.3: Experimental setup using the microwave imaging with an open-ended waveguide:

(a) size of the aperture, (b) schematic diagram of the setup

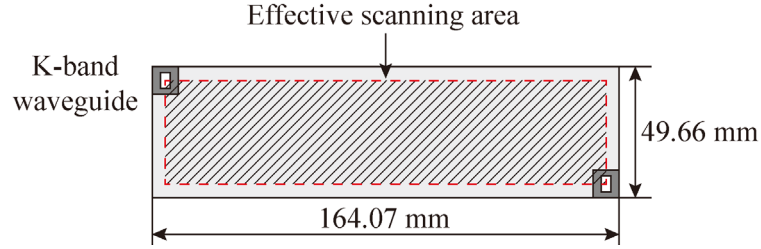
As shown in Fig. 4, the raster (2D) scanning is performed over the skin with the effective scanning area of 141.74 mm \times 27.28 mm. The step size used for scanning is 1 mm with the standoff distance of 5 mm. T-joint I is used to thoroughly study the characteristics of the microwave imaging. It should be noted that there is a slight increase in the thickness from the edge to the central region on the top surface due to the introduction of the flange underneath, which would affect the propagation of the electromagnetic waves and the reflected energy. The distances between the centre of the waveguide at the origin and the locations of interest are demonstrated in Fig. 5.

Fig.4: 2D scanning over the top surface of T-joint I

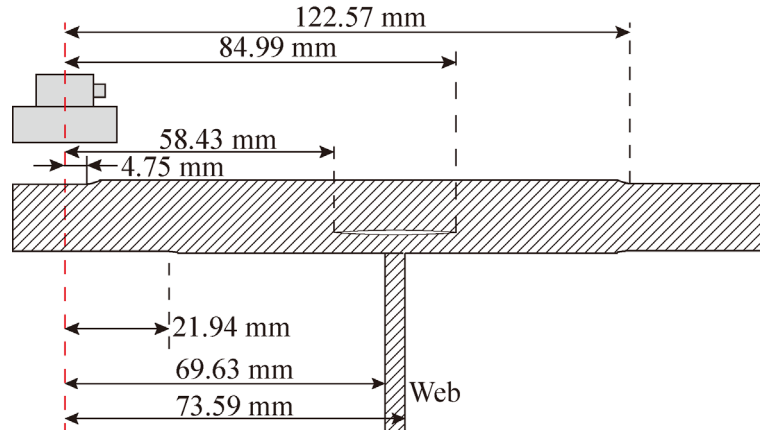
Fig.5: Detailed locations of interest in T-joint I with respect to the starting point of the waveguide

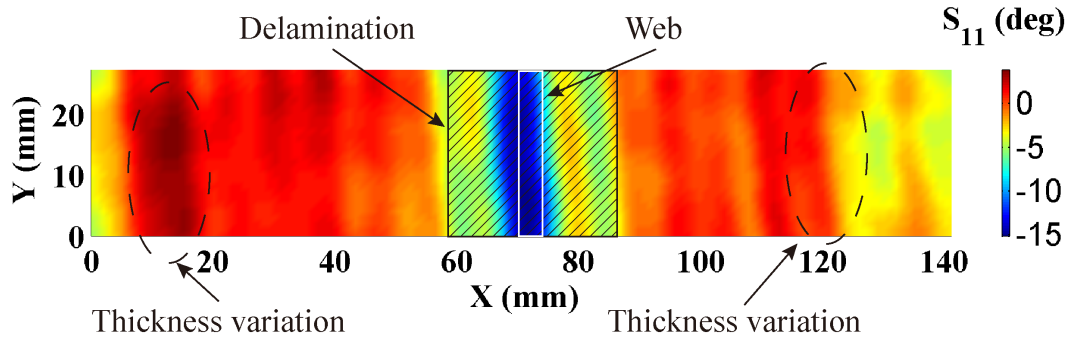
As a one-port measurement, only the reflection coefficient S_{11} is acquired from the analyser. It has been found that phase information is more sensitive than the magnitude [11]. Accordingly, the distribution of the phase at each sampling position is plotted. As seen in Fig. 6, at the inspection frequency of 19 GHz, both the delamination and the variation of the thickness can be detected. In addition, the presence of the web is well presented. It is shown that the size of the blue region is slightly larger than the real size of the web, which is primarily due to the transition in the thickness from the skin to the web and the intrinsic limited resolution provided by the technique that is dependent on the waveguide dimensions [12].

Fig.6: Microwave inspection of delamination in T-joint I at 19 GHz

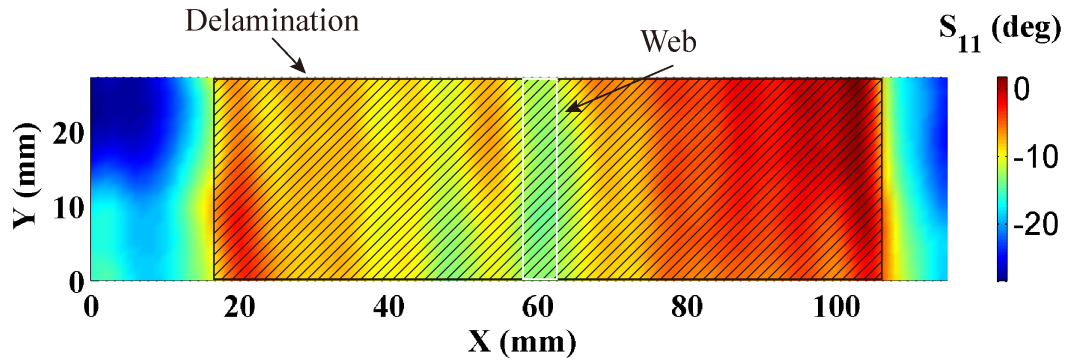
As presented in Fig. 7, a similar result is found in T-joint II. The colour difference in the delamination region reveals the severity of the defects inside the joint. However, the same colour in different figures is not comparable, and the colour different indicating varied signal responses is only meaningful for a specific joint.

Fig.7: Microwave inspection of delamination in T-joint II at 19 GHz

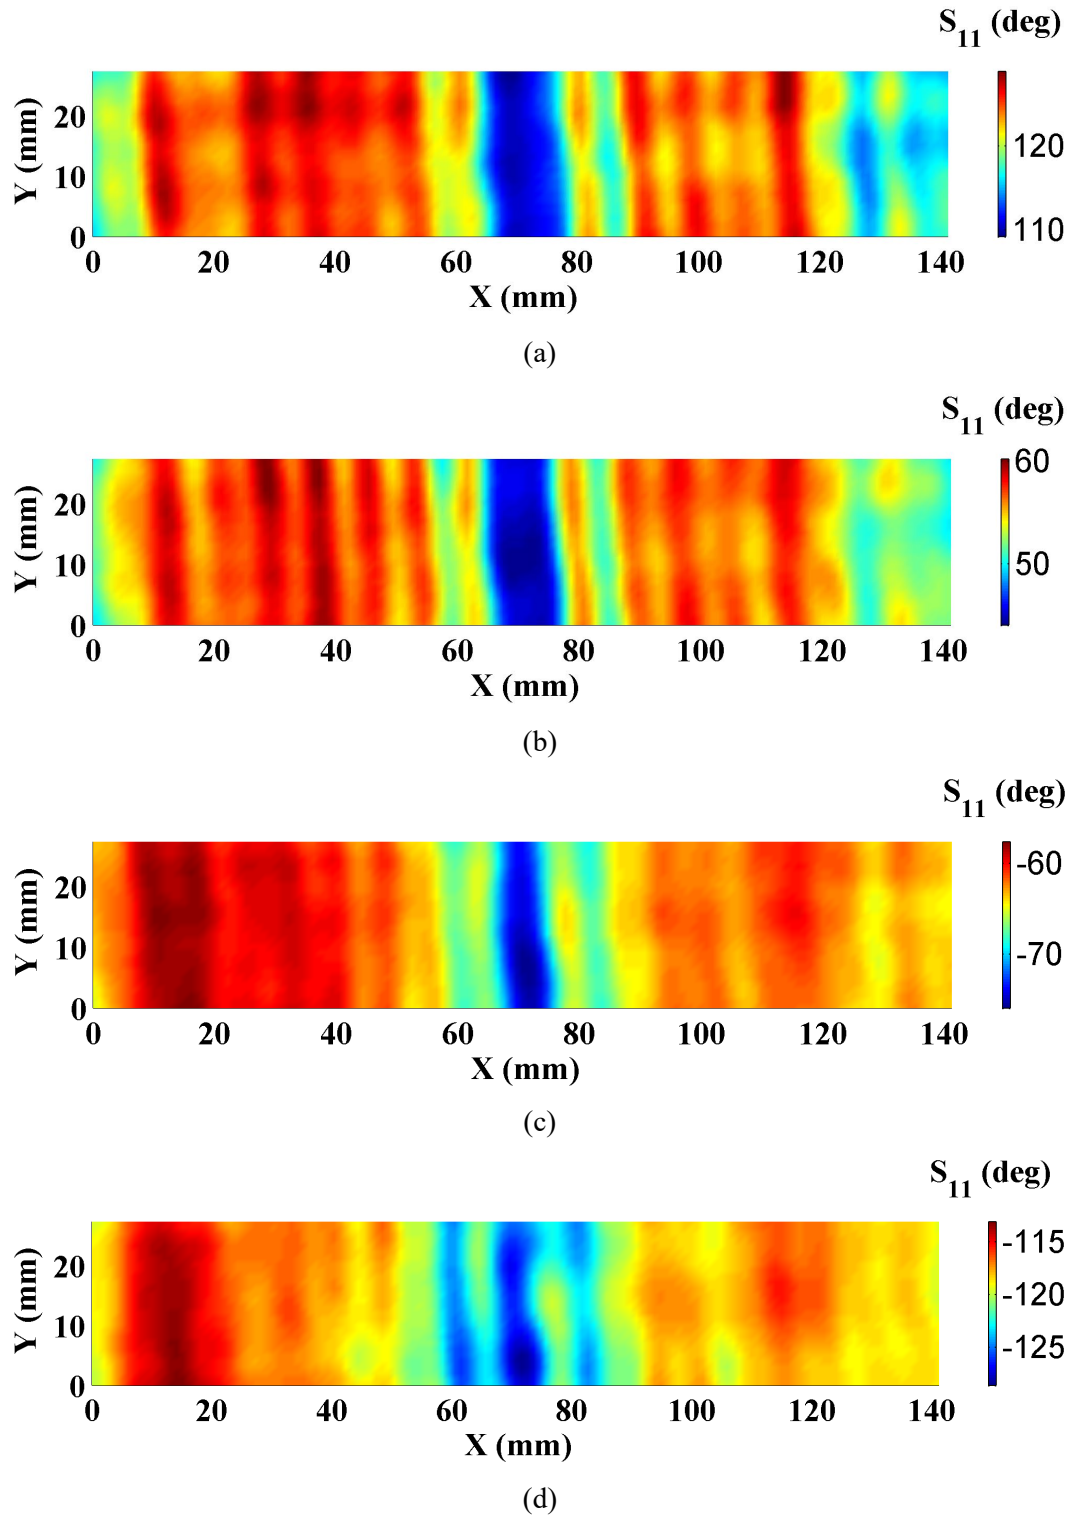
- (1) In order to study the effect of the inspection frequency on the signal response for the T-joint I case, four other inspection frequencies (i.e., 18 GHz, 18.5 GHz, 19.5 GHz and 20 GHz) are examined. In Fig. 8, there is no clear difference between the distribution for the frequencies below 19.5 GHz. At the frequency of 20 GHz, the size of the delaminated region is around 40 % larger than that in the cases with smaller frequencies. The location of the web can still be identified, although two unexpected blue strips exist on each side. The inconsistency of the inspection results is primarily due to the selection of the inspection frequency. It was found that the optimal frequency for inspection can only be determined from a well-prepared calibration [13]. For the present case, the recommended frequency range for the delamination detection is 18-19.5 GHz. However, it is noted that the choice of the optimum frequency range can only be made case by case.

Fig.8: Inspection of T-joint I at varied frequencies:

(a) 18 GHz, (b) 18.5 GHz, (c) 19.5 GHz, (d) 20 GHz

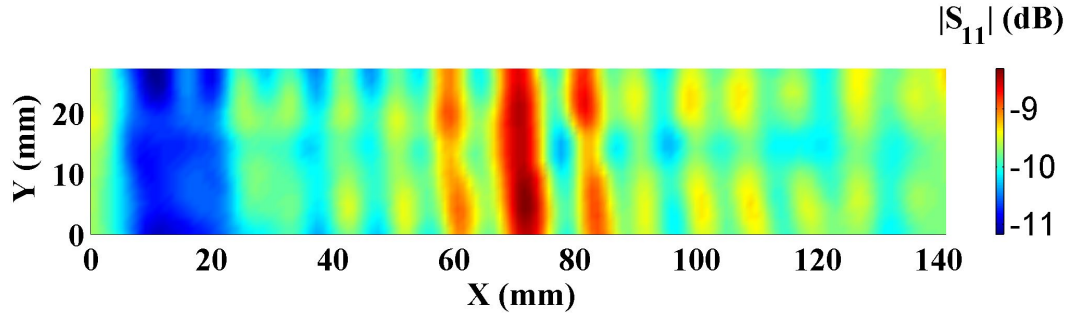
(2) Here, the images of magnitude and phase for the delamination inspection are compared. As presented in Fig.9, the location of the web in T-joint I can be captured by the magnitude image at 18 GHz, but not the delamination, which can be explained by the little attenuation of the electromagnetic energy in its presence (air gaps). The electromagnetic wave could penetrate

through the thickness, as the glass fibre composites are low-loss dielectric. Therefore, the magnitude is more sensitive to the variation of the thickness when compared with the phase information. In practice, the magnitude and phase information should be combined for damage evaluation.

Fig.9: Microwave image of T-joint I represented by the magnitude profile distribution at 18 GHz
